**PROJECT** Windsor STW External Refurbishment & Structural Remediation

LOCATION Ham Lane, Old Windsor, SL4 2JS

## Windsor Sewerage Treatment Works External Refurbishment & Structural Remediation

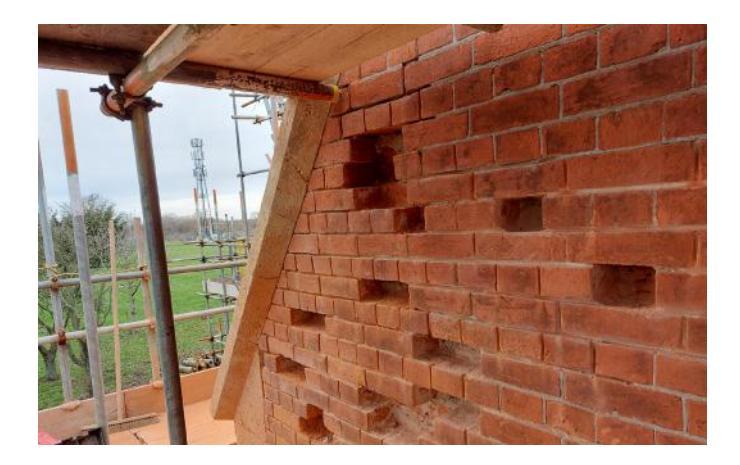
- We took great care to secure the unstable masonry, Working from a NASC approved scaffold design, we strengthened the gable end walls by carefully stitching and tying Helifix Cem Tie rods at staggered vertical/horizontal centres through the brickwork to hold the leaves of the wall together. We also installed Helifix Bow Ties under the coping line to tie back into the first two main roof rafters. We supported these with additional PFC steel support beams restrained at the ridge, purlins and eaves. All subsequent internal masonry repairs were co-ordinated with the roof repairs and the new structural steel frame installation.
